ARCHEOLOGICAL INVESTIGATIONS AT THE LINCOLN HOME NATIONAL HISTORIC SITE, SPRINGFIELD, ILLINOIS

By
Floyd Mansberger

NORTHERN ILLINOIS UNIVERSITY
DEKALB, ILLINOIS

Prepared For The National Park Service
Midwest Archeological Center-Lincoln, Nebraska

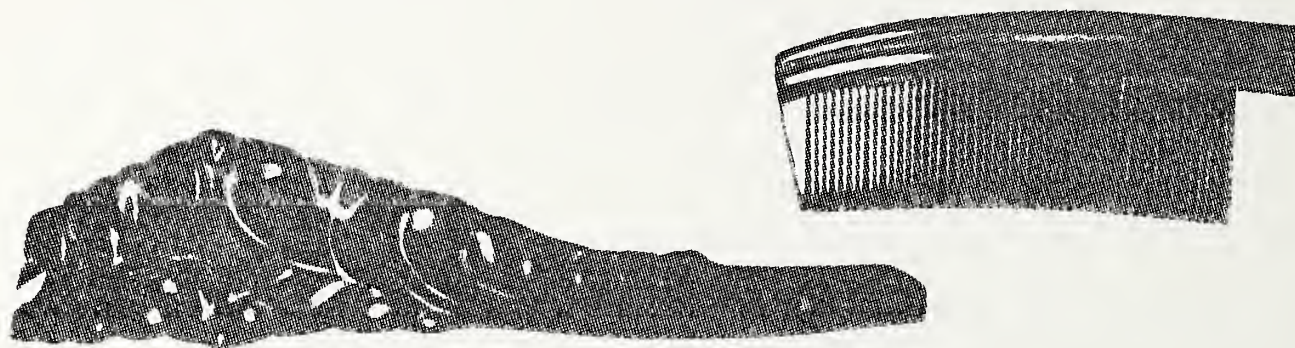
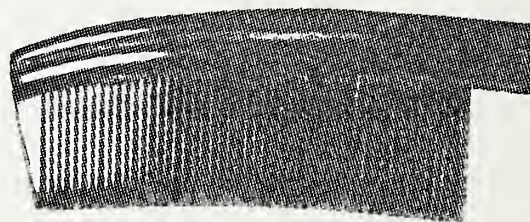
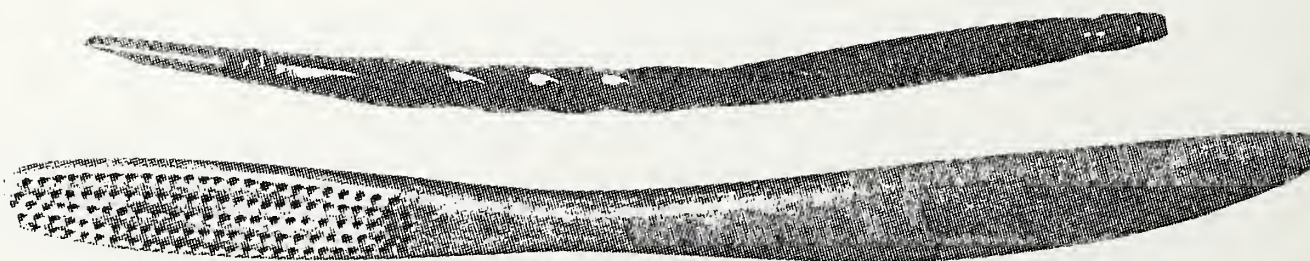
FIGURE 90. Personal Items Recovered by Hagen's 1951 Excavation, Rubbish Pit.

Other unique items found in this trash pit include a wide range of personal items (Figure 90), such as hard rubber combs and barrettes, a stylus, and a bone toothbrush. Numerous doll parts were found in this feature. These included examples with high foreheads and pulled back hair typical of the 1840's and 1850's as well as varieties with hairstyles typical of the late 1850's through 1880's (Pritchett and Pastron 1983:327). Several slate pencils -- although not illustrated -- were also found. A Parian matchbox lid and ceramic "steamer/strainer" were also found in this pit (Figure 91). Of unusual nature, and possibly representing a gaming piece, was a small carved bone artifact (Figure 92). The faces of this domino-sized artifact have oriental markings similar to those found on mah-jong gaming pieces. The top of a turned bone chess pawn, similar to one found at the Smith mansion House in Nauvoo, was also found by Hagen (DeBarthe 1979: 28).

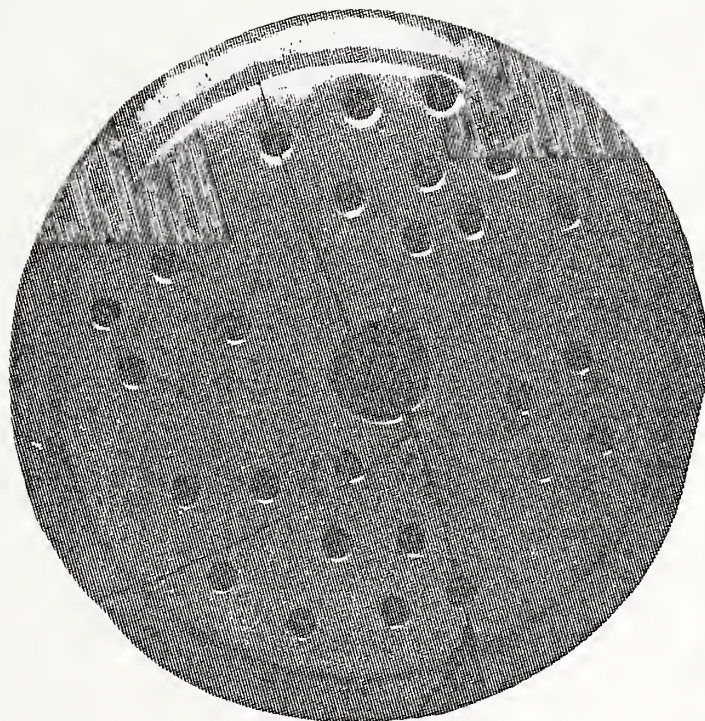
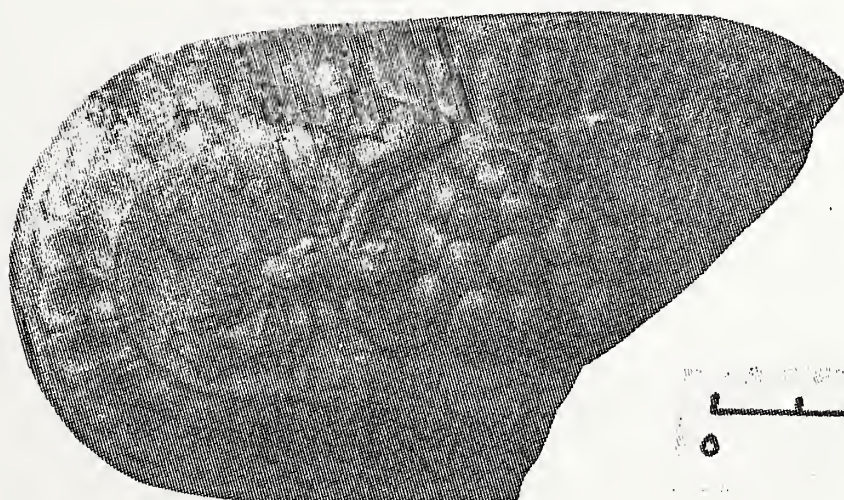
FIGURE 91. Ceramic Items Recovered From The Rubbish Pit During Hagen's 1951 Excavations.

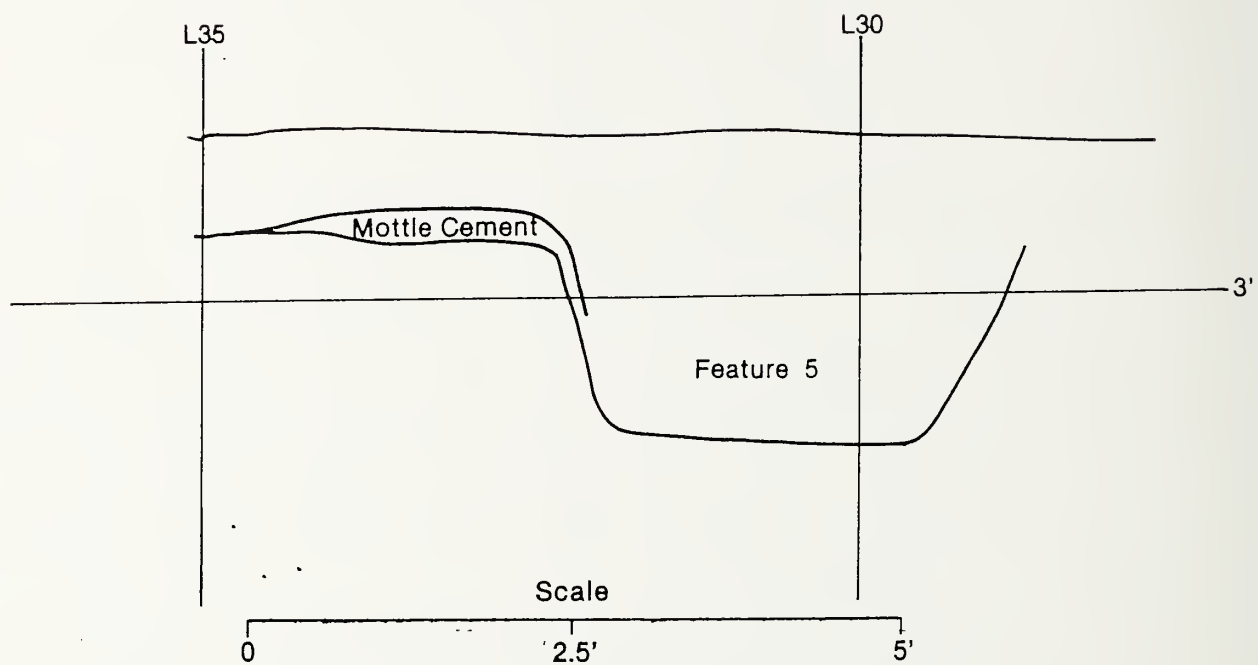
FIGURE 93. Lincoln Site, Hagen's (1951) Feature #5, East Wall Profile (Notes on file at the Lincoln Home National Historic Site, Springfield).

Feature 5 is a small circular (diameter = 115cm) pit feature located at 20 L 32, immediately southwest of the rubbish pit (Feature 4). Figure 93 is a cross-section of that feature. Hagen says, "the fill was clayey, appearing almost undisturbed but for yellow clay spots and frequent coals...it may have been dug for a bush." If indeed the location of a bush, it would have strategically hidden from view the unsightly trash pit from passersby on the street. Artifact density was moderate, with a total of 72 artifacts having been recovered from this feature. Ceramics from this feature included 7 (12.3%) transfer printed whiteware sherds, and 3 (5.3%) relief decorated ironstone sherds. The remainder were undecorated ironstone wares. A single improved tool bottle neck was also found with a milk-glass canning jar lid fragment. Of particular interest are the two Civil War-era lead bullets ("minie balls") found in the pit. Many of these items could have been deposited when the bush/plant was removed from the ground probably at the time Oldroyd built his new barn (1889).

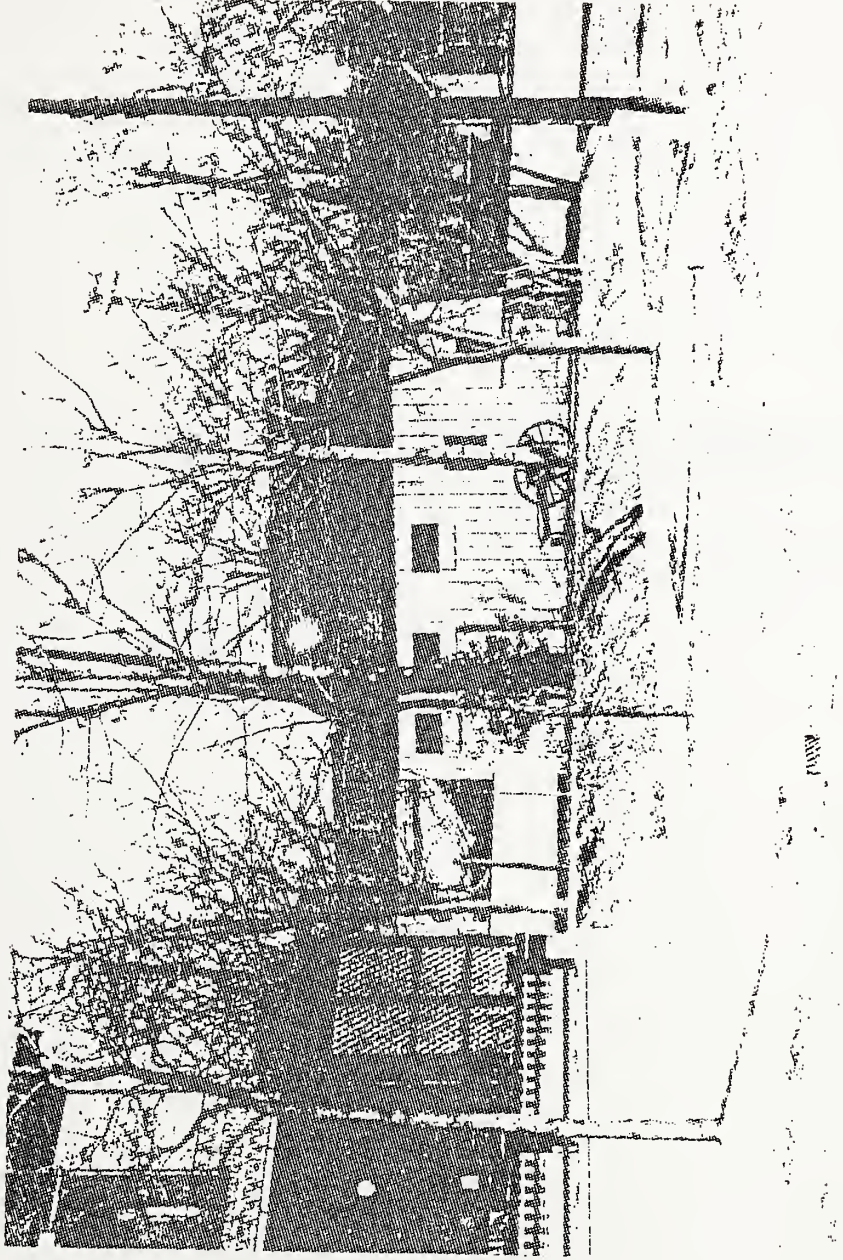
FIGURE 94. Photograph of the Oldroyd Barn, Circa 1890 (Courtesy of the National Park Service).

Oldroyd Barn (Figure 94). The Oldroyd barn, built circa 1889 to replace the Lincoln barn, was situated in the far northeast corner of the lot. This barn was probably built in 1889 by Buck and McKee for a cost of \$180 (Temple 1984: 105). Archeologically, the barn is represented by five brick foundation walls. The south wall does not connect to the remainder of the structure. This is difficult to interpret unless the unconnected area represents a disturbance where the bricks were removed after demolition of the barn. Hagen speculated from the lack of bricks that there was a door in the south wall near the back alley. A row of posts extend from the southwest corner of this barn suggesting that a fence was present.
